# **vierkantpaars**extern #03

Historic  
Buildings

# Historic Buildings

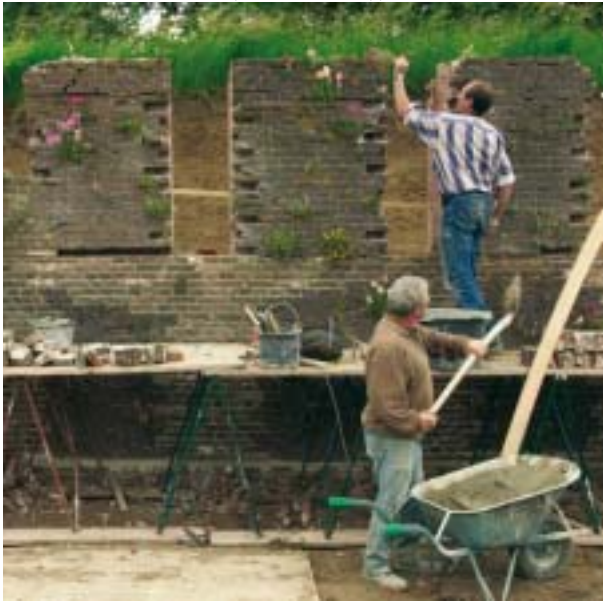
Plant conservation, Gorinchem fortification wall, photo: Marcel Köppen

The unique vegetation found on fortification walls can have positive (protective) and negative (disintegrative) effects. "In Zaltbommel we decided to place a covering layer of clay-bottomed sods on top of the wall as a buffer against rain and frost. Time will tell whether it works or not". RDH always advises performing an ecological survey in order to preserve unique plants. In Gorinchem, parts of the masonry which supported flowering plants, but could not be maintained due to the flood-control function of the ramparts, were removed and transported to another location.

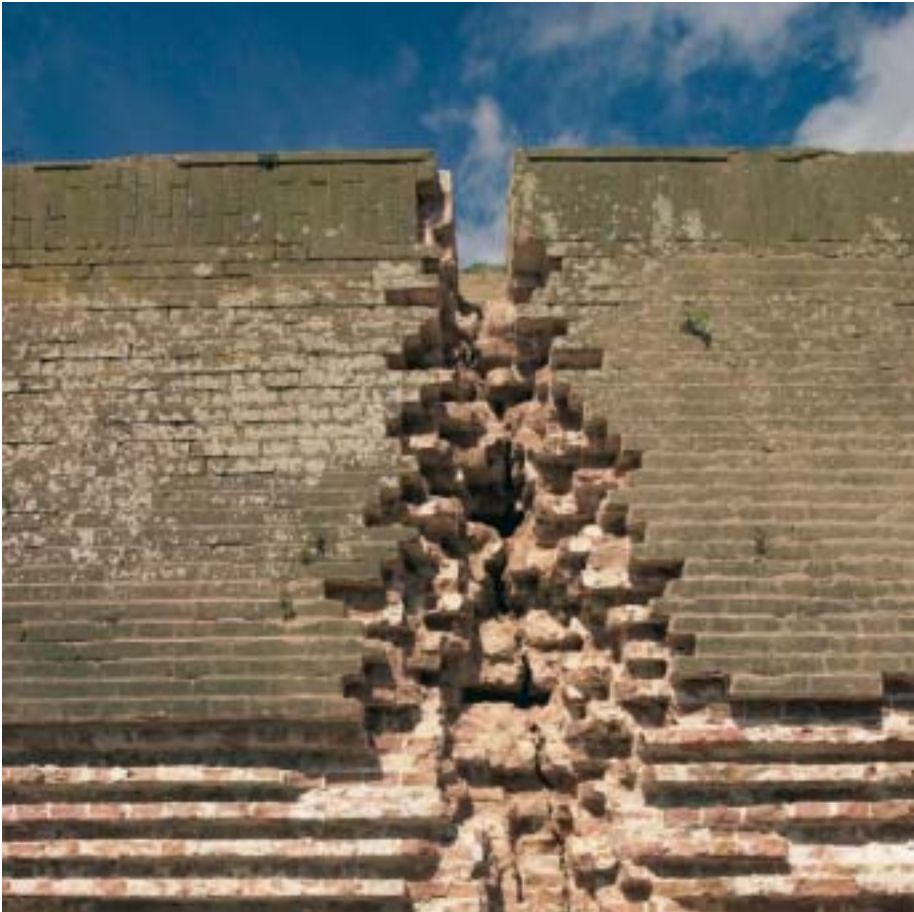
Repairing holes in the Gorinchem fortification wall, photo: Marcel Köppen

The restoration of historic fortifications demands a special approach. Many old fortification walls were built using a combination of earthworks and masonry, with (underground) brickwork spaces. The constant damp and ground pressure cause specific problems. The fortification wall of Gorinchem is doubly special, as it still functions as a primary flood-control line, and must therefore meet modern hydrological demands. "We inventoried the mortar and brick types used", stated restoration architect Erik-Jan Brans. "Based on an analysis of the characteristics of these materials, we composed a specific recipe for mortar which is appropriate for that type of brick. We had new bricks baked especially for this project."

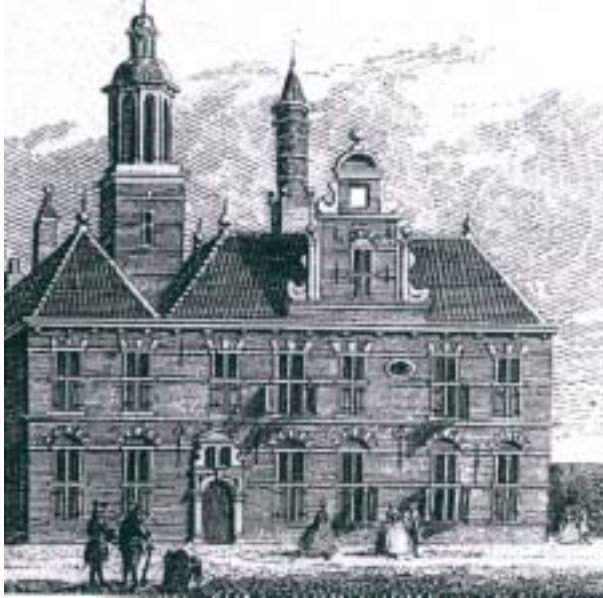
Condition before restoration

RDH was brought in to preserve the building and for the restoration of the façades. This was crucial, as large parts of the ornament work had fallen off. Parts of the water gutters and the framework were missing, which allowed rainwater to damage the masonry. Previous repairs had left iron dowels, which had begun to expand due to the damp. Ruissen explains: “A hundred years ago, people chose to preserve the appearance of the façades, regardless of the materials used. We found pieces of wood used instead of plaster, for example.”

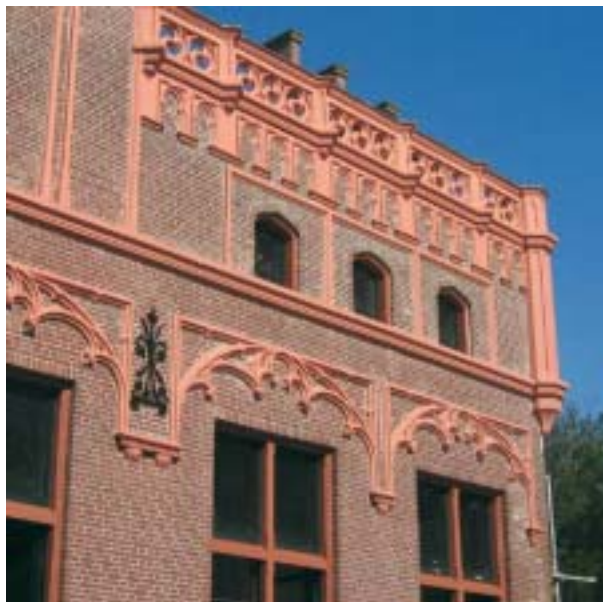
The original colour was re-applied

At the beginning of the project, the stucco was a mouse-grey colour. A pigment analysis showed that the original covering layer had a chalky filling with poppy-seed oil, with some madder added for colour. This gave the plaster the soft pink colour which is now again displayed on the façade. The masonry also received extra attention. During previous maintenance work, the joints between the bricks had been widened with a grinder to ease application of new mortar. This irreparably damaged the fineness of the exterior brickwork. These damaged surfaces were repaired with joints made with appropriate materials. Only the northern top façade was left in original condition.

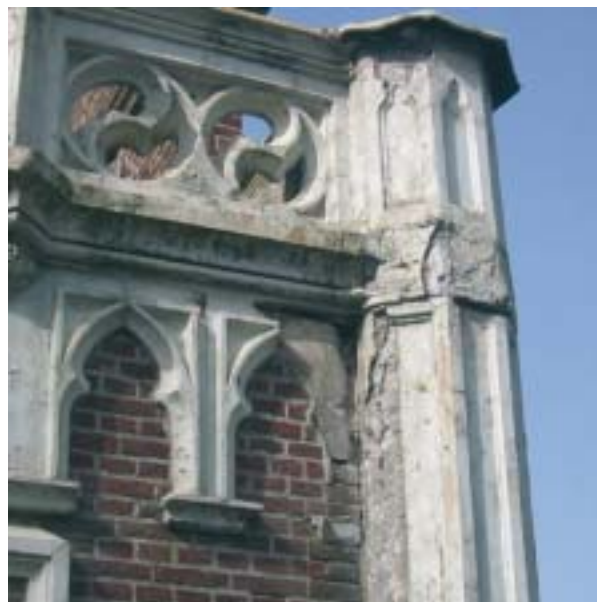
Old damage

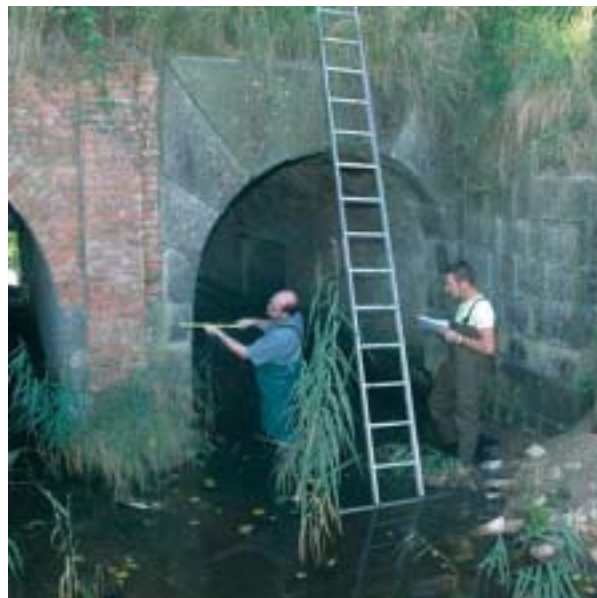
Initial survey of the Zwarthoek sea lock

A restoration always begins with an initial survey which measures the degree of deterioration of the building's various elements. This assessment is not guided by regulations, but is the result of the judgment and intuition of an experienced structural engineer. When buildings are still in use, the engineer often limits his observations to his experienced eye and his nose for defects and 'pests'. "A feeling for this work is at least as important as professional education", according to Luteijn. "When we suspect more serious defects, and estimates are not sufficient, then we have to take samples".

RDH has inspected many buildings: (wind) mills, churches, castles and houses, but also fortification walls, sluices and canal locks. The inspection method determines the quality of the survey. Inspection of masonry near the roof, for example, is more effective with a magnifying glass than with a telescope. Luteijn: "Sometimes we work from aerial work platforms, sometimes we are wearing wading boots and are up to our waists in water. That's part of the job. What's important is that we can offer quality. Sometimes that makes the survey more expensive, but it pays off down the road during the restoration."

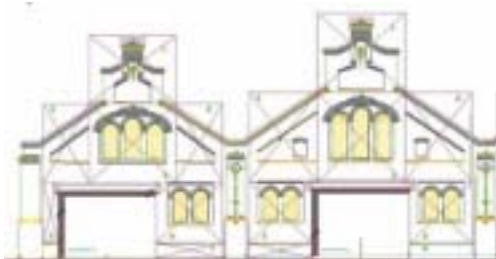
Salvage drawing GVB Halls

This project is part of the complete reorganisation of the site of the former gas factory (Oostergasfabriek) in Amsterdam. RDH's expertise will be utilised for the GVB halls. These halls will house the Centre for Fine Arts, and the plan is that the current halls (four naves of various widths, in total 54x93 m deep) will be brought back to two naves of different widths of in total 27x36 m deep. These halls were initially a part of the gas factory, and were subsequently used as a depot for the (horse-drawn) trams of the Municipal Transport Company (GVB). Due to the serious soil pollution, up to six meters deep in some places, the halls have been largely demolished and will be re-built after the cleanup. RDH has surveyed, measured, and drawn the buildings and produced the plans for their demolition, salvage, and reconstruction. During the salvage, storage and reconstruction phases, RDH will supervise the project and act as outside consultant.
